ULTRASONOGRAPHY

ARTIFACTS

21.1. INTRODUCTION

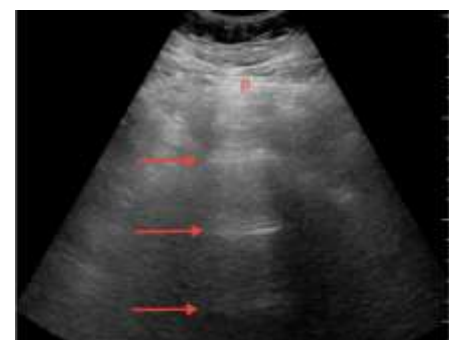
The ring-down artifact is a distinctive type of ultrasound artifact that appears as a continuous bright echo extending downward (distally) from a structure containing gas. It is often confused with the comet-tail artifact because both appear as bright, tapering trails on the image. However, the underlying cause of the ring-down artifact is different. Instead of resulting from multiple reflections between closely spaced interfaces, as in the comet-tail artifact, the ring-down artifact occurs due to the resonance of gas bubbles within tissues or fluid. When the ultrasound beam strikes a small collection of gas bubbles, these bubbles begin to vibrate or “ring,” continuously emitting sound waves even after the original ultrasound pulse has passed. This ongoing vibration produces a continuous, bright, vertical echo that appears as a solid, flame-like band extending downward from

Fig: 21.3. Ring Down Artefact

the site of the gas collection. On the ultrasound image, the ring-down artifact typically appears as a bright, continuous line or band that gradually tapers in intensity with depth. It is most commonly seen in areas where gas is present, such as the gastrointestinal tract, abscess cavities, or the biliary system. For example, it may be observed in conditions like pneumobilia (air in the biliary tree), emphysematous cholecystitis (gas in the gallbladder wall), or gas-forming infections in soft tissue. The presence of a ring-down artifact is therefore a useful indicator of gas within a region that may not normally contain it, alerting clinicians to possible infection, perforation, or other pathology. In comparison to the comet-tail artifact, the ring-down artifact differs both in mechanism and appearance. The comet-tail artifact arises from multiple reflections between solid, closely spaced interfaces such as cholesterol crystals or metallic clips, producing a short, discrete series of bright echoes. In contrast, the ring-down artifact arises from the resonance of gas bubbles that continuously emit sound, resulting in a longer, solid, and more uniform band. Recognizing the difference between these two artifacts is important in clinical practice, as it helps accurately identify the nature of the underlying tissue and avoid diagnostic confusion [5].

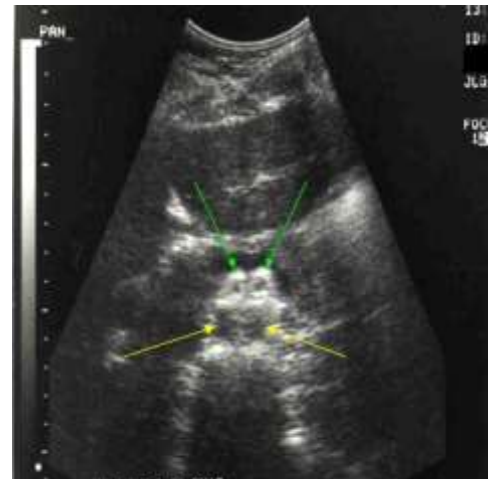
The refraction artifact in ultrasound imaging occurs when the ultrasound beam changes direction (bends) as it passes through tissues that have different propagation speeds or acoustic properties. This bending is most commonly observed at interfaces where tissues of different densities, speeds, or stiffness meet—for example, at the junction between fat and muscle, tendon and fluid, or soft tissue and bone. When the sound beams bends, the ultrasound machine incorrectly assumes that the returning echoes have traveled in a straight line. As a result, the system miscalculates the position of the reflecting structure, producing lateral displacement, duplication, or distortion of the true anatomical structures on the image [7].

A common clinical example is seen when imaging curved or oblique interfaces, such as the rectus abdominis muscle, bowel loops, or gallbladder wall. In these cases, a structure may appear shifted sideways or duplicated, creating the illusion of an additional object adjacent to the real one. Refraction artifacts are particularly prominent when scanning structures with smooth curved surfaces, where the beam enters at an oblique angle and exits at a different path, exaggerating the displacement of echoes. The refraction artifact occurs because the ultrasound system is built on the assumption that sound waves travel in a straight line at a uniform speed of 1540 m/s. When this assumption is violated, as happens when sound bends through tissues with differing speeds, the machine misplaces the location of echoes on the display, leading to inaccurate imaging. Recognizing refraction artifacts is clinically important to prevent misinterpretation of false structures as real pathology, such as cysts, masses, or foreign bodies. Simple corrective measures include changing the angle of insonation, repositioning the transducer, or scanning from a different acoustic window, which often eliminates or reduces the artifact.

Fig: 21.5. Refraction Artifact

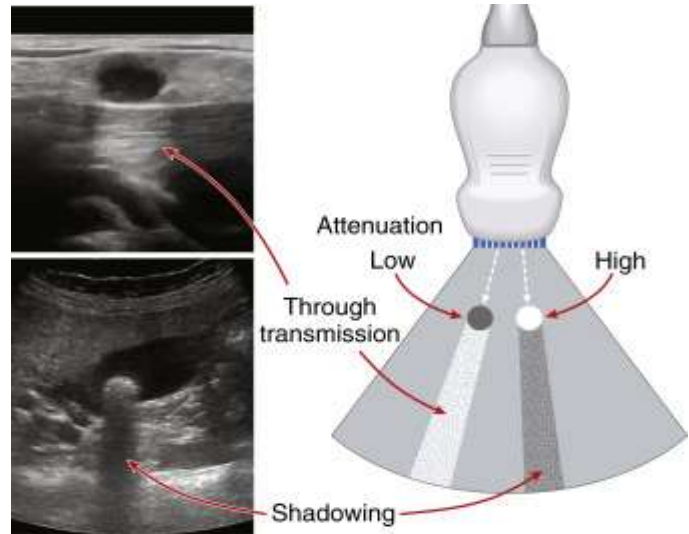
Acoustic shadowing is a commonly encountered ultrasound artifact characterized by a dark or anechoic area appearing behind a structure that strongly attenuates the ultrasound beam. This artifact occurs when the ultrasound waves are either absorbed or reflected by a highly dense or highly reflective object. Such structures prevent the ultrasound waves from penetrating deeper into the tissues. Because the ultrasound system relies on returning echoes to form an image, the area distal to the attenuating structure receives little or no echoes, resulting in a dark or black region on the image. This gives rise to the characteristic “shadow” effect, which can be used as a diagnostic clue in various clinical settings. On ultrasound, acoustic shadowing appears as a dark or anechoic region directly posterior to the structure causing attenuation.

Fig: 21.6. Acoustic Shadowing Artifact

The edges of the shadow are usually sharp and well-defined, particularly when produced by highly reflective structures such as bones or stones. The intensity and extent of the shadow can vary depending on several factors, including the density and composition of the attenuating object and the frequency of the ultrasound transducer used. Higher-frequency transducers generally produce more pronounced shadows, while denser structures generate deeper and darker posterior shadowing, making the artifact both visible and diagnostically useful.

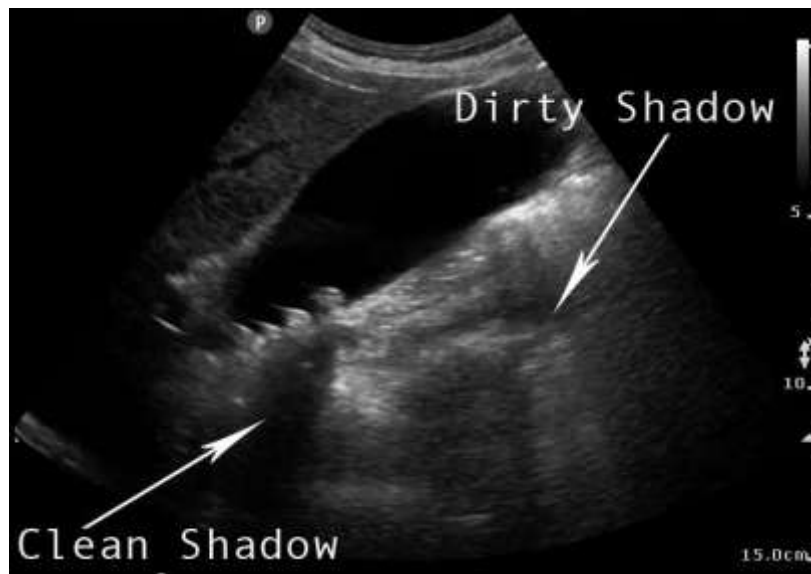
Feature	Clean (Dense) Shadowing	Dirty Shadowing
Cause	Highly reflective structures (e.g., stones, bone, metallic objects)	Gas-containing structures (e.g., bowel gas)
Appearance	Uniform, sharply defined dark area	Heterogeneous, poorly defined dark area
Echogenicity	Completely anechoic posterior to the object	Partial or patchy anechoic region due to scattering
Diagnostic Clues	Confirms presence of stones, bone margins, or metallic objects	Indicates gas-filled structures, helps differentiate bowel loops or gas from solid lesions
Mechanism	Strong reflection or absorption of sound waves prevents penetration	Scattering and absorption of sound waves by gas bubbles prevent clear transmission

Fig: 21.7. Dirty and Clean Shadowing

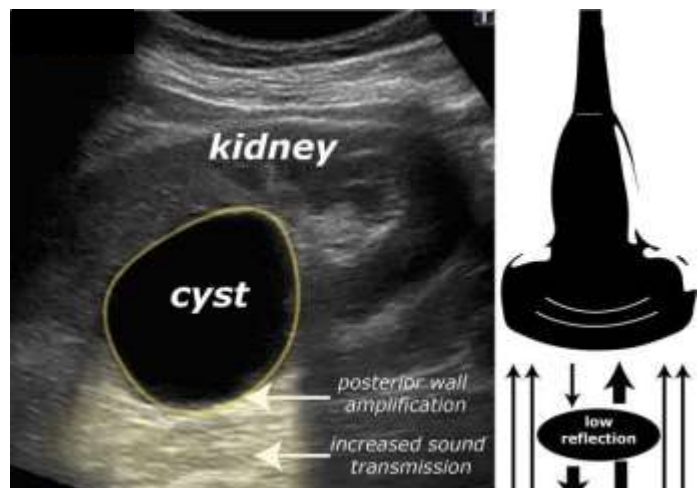
The enhancement artifact, also referred to as posterior acoustic enhancement, is a key ultrasound phenomenon characterized by increased brightness or echogenicity in tissues located immediately posterior to fluid-filled structures. Common examples of such structures include simple cysts, the urinary bladder, gallbladder, bile ducts, or blood vessels. The underlying mechanism is based on the low attenuation of ultrasound waves by fluid. Unlike solid tissues, which absorb or scatter a significant portion of the sound energy, fluid allows the majority of the ultrasound beam to pass through with minimal energy loss. Consequently, tissues located beyond the fluid receive a higher intensity of ultrasound waves, producing stronger returning echoes and resulting in a brighter or hyperechoic appearance on the image. The artifact is most pronounced when the fluid collection is anechoic and homogeneous, such as in a simple cyst, because the ultrasound beam is transmitted efficiently

Fig: 21.8. Posterior Enhancement Artifact

without internal scattering. In contrast, complex cysts containing septations, debris, or haemorrhage may produce partial enhancement or irregular posterior brightness. The frequency of the transducer also influences the degree of enhancement: higher frequencies produce more noticeable echogenicity due to their greater sensitivity to variations in beam attenuation. Similarly, the size and depth of the fluid-filled structure affect the artifact's appearance; larger or deeper cystic structures tend to produce more prominent posterior enhancement. Clinically, posterior acoustic enhancement is highly useful in differentiating cystic from solid lesions. For example, a simple renal or hepatic cyst will appear anechoic with marked posterior enhancement, whereas a solid tumour or mass will not generate this artifact and may even produce posterior acoustic shadowing due to higher attenuation. Enhancement artifacts are also valuable in vascular imaging, aiding in the visualization of fluid-filled vessels and differentiating them from surrounding tissues. Recognition of this artifact is essential for accurate ultrasound interpretation, as it provides critical diagnostic information while preventing misidentification of posterior bright echoes as pathological lesions.

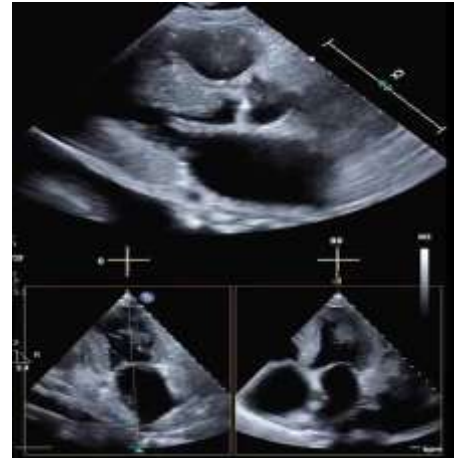
This artifact is particularly evident in fluid-filled regions, such as simple cysts in the liver, kidney, or ovary. A cyst that is truly anechoic may appear to contain internal echoes, debris, or septations, mimicking a complex cystic lesion or even a solid mass. The severity of the artifact depends on several factors, including:

- **Beam Elevational Thickness:** Wider beams increase the volume of tissue sampled, increasing the likelihood of averaging.
- **Transducer Frequency:** Low-frequency transducers generally produce thicker beams, while high-frequency probes offer better elevational resolution and reduce the artifact.
- **Focal Zone Position:** Poorly positioned focal zones can exacerbate the artifact, as echoes from outside the plane are less well-resolved.
- **Scanning Angle:** Off-axis scanning can increase the inclusion of structures from adjacent planes, worsening the artifact.

Fig: 21.10. Slice Thickness Artifact

Clinically, the slice-thickness artifact can lead to misinterpretation of cystic lesions, potentially resulting in unnecessary further imaging or interventions. Recognizing this artifact is critical to distinguish true internal content from spurious echoes. Strategies to minimize its effect include:
